# A Machine Vision Profile Measurement System for Effective Wheel Maintenance

Kambiz Nayebi, Ali Yousefi & S.  
Gelichkhani

*Sharif University of Technology*

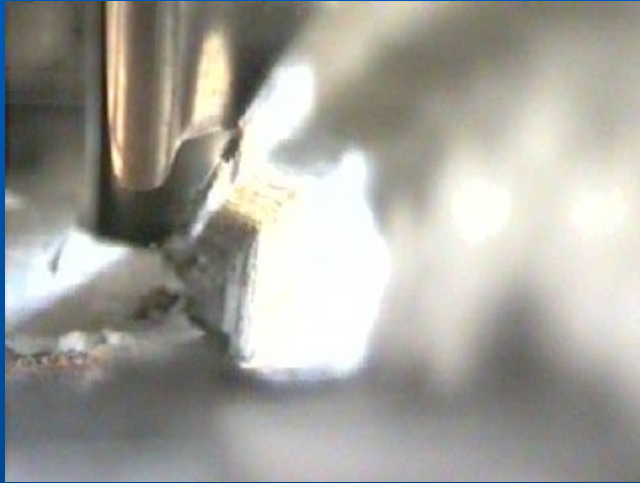
**No lighting**  
**Daytime**

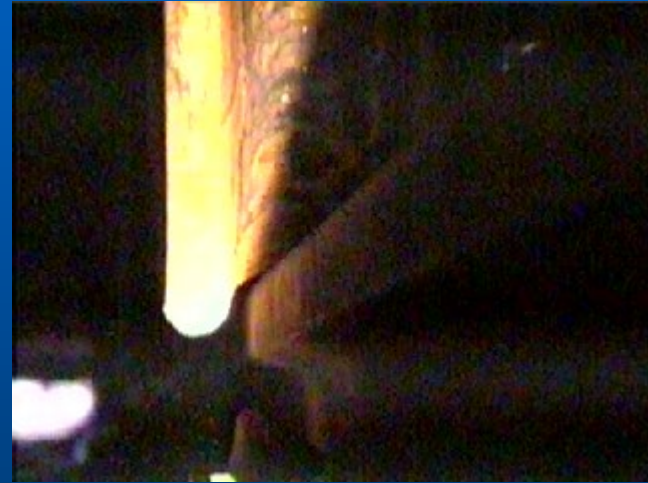
**with proper lighting**  
**daytime**

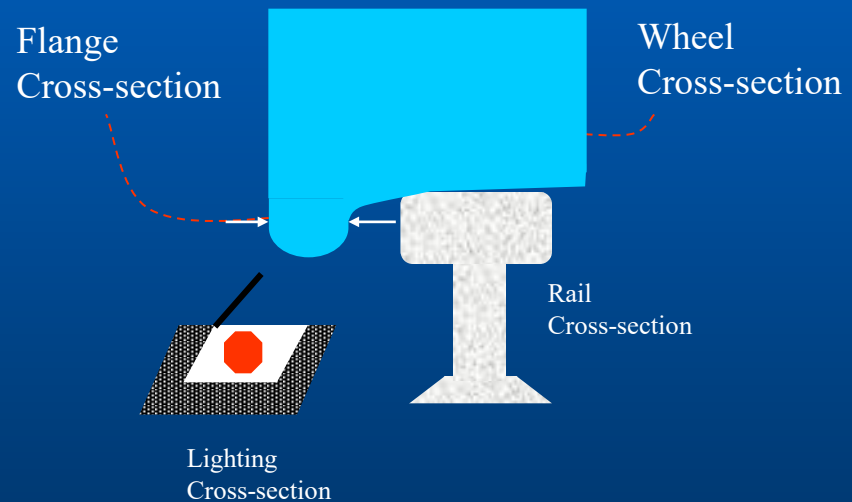
- Direct lighting
- 2000 watts
- 40 cm length
- Light concentrated on flange
- 320x240 resolution
- One or two images per wheel
- Color imaging
